Planning Committee

**PC2307-1 HERBERT STREET, NO. 21 (LOT 23), NORTH FREMANTLE -
DEMOLITION OF EXISTING SINGLE HOUSE AND INCIDENTAL
STRUCTURES (JZ DA0127/23)**

Attachment 1 - Demolition Plan & Structural Engineer Report

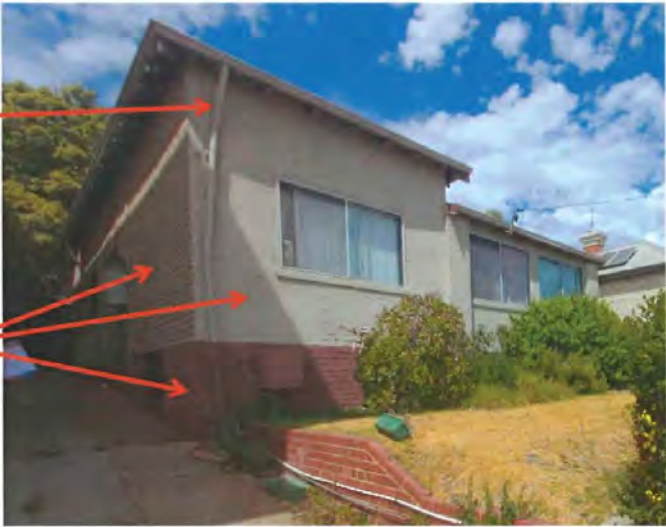
WEST ELEVATION

Poor Rain water system

Damaged Brick veneer cladding

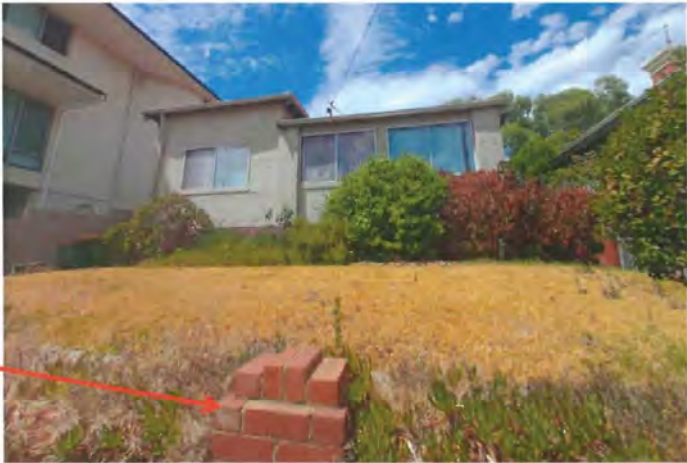
WEST ELEVATION

Boundary brick walls in disrepair

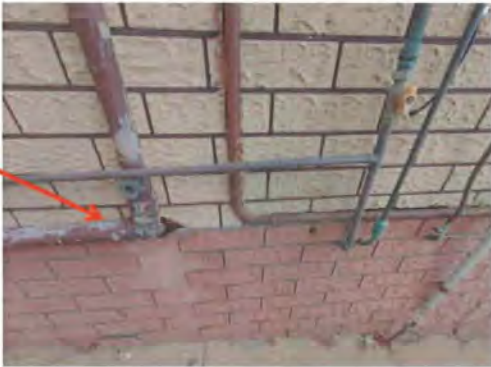
HEATING SYSTEM - NORTH WALL

Copper heating system
Fixed into cladding

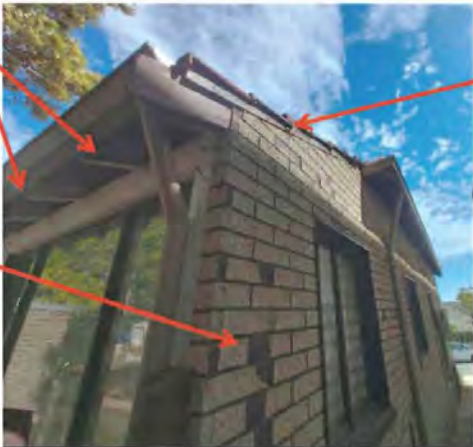
NORTH WEST CORNER OF HOUSE

Damaged roof trusses

Damaged brick veneer
cladding

Missing barge
boards

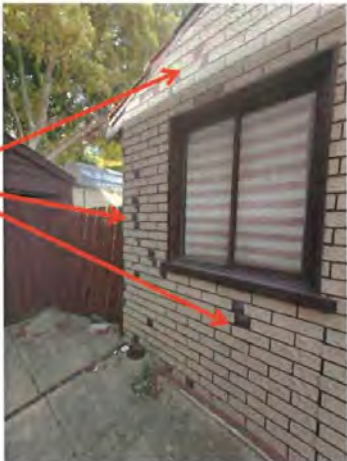
NORTH WEST CORNER OF HOUSE

Damaged brick veneer
cladding

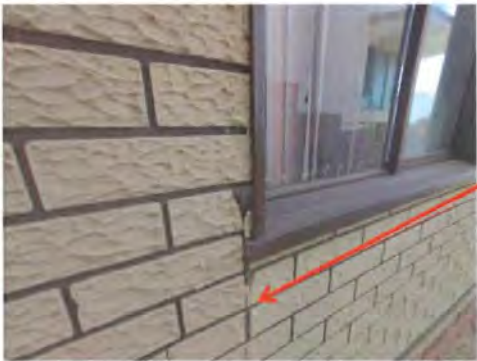
NORTH WEST CORNER OF HOUSE

Cracked brick veneer
cladding

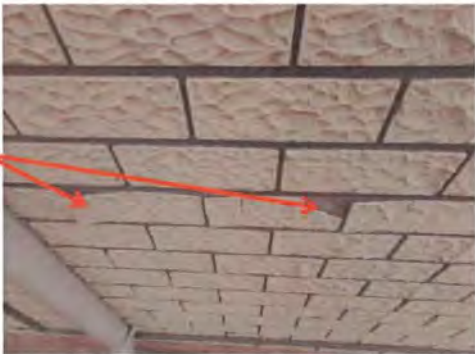
NORTH WEST CORNER OF HOUSE

Damaged and loose
Brick veneer cladding

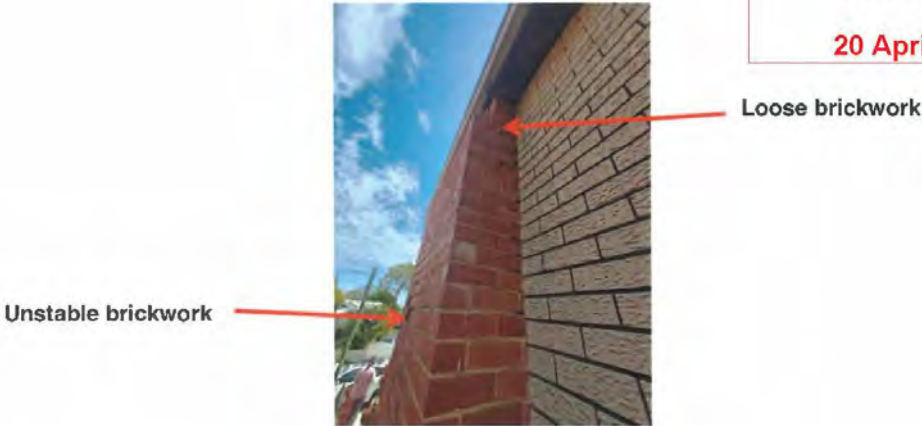
CHIMNEY - SOUTH WALL

The chimney serving the lounge is made of face brick. The external brickwork surface at the rear end of the chimney is loose and in a state of collapse.

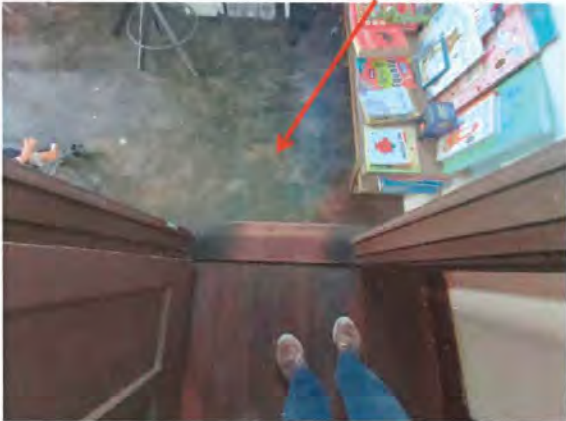
ENTRANCE – VERANDA TO HOUSE

Worn floor lining

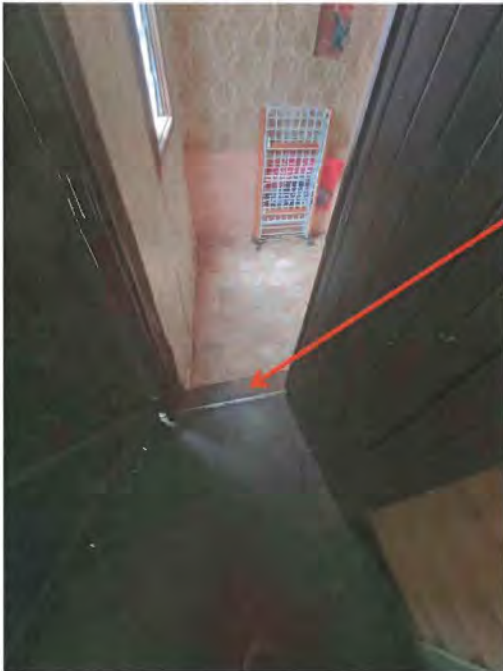
ENTRANCE TO PLAY ROOM

Restricted entrance to playroom

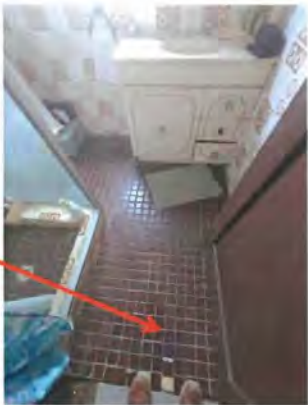
BATHROOM FLOOR

Buckled & lifting
floor tiles

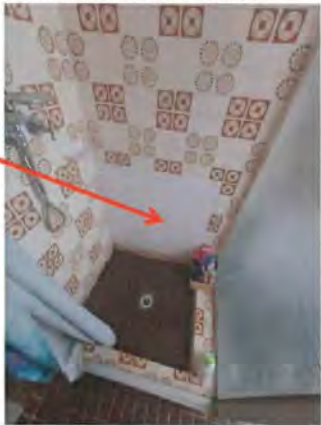
SHOWER CUBICAL

Damaged & replaced wall tiles

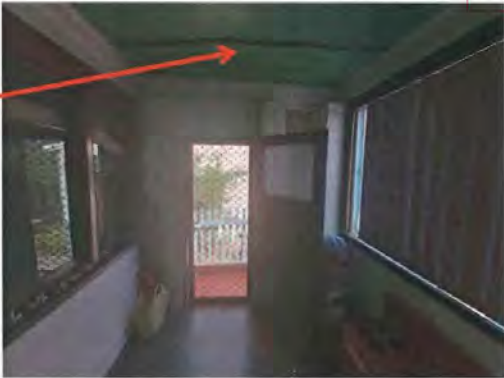
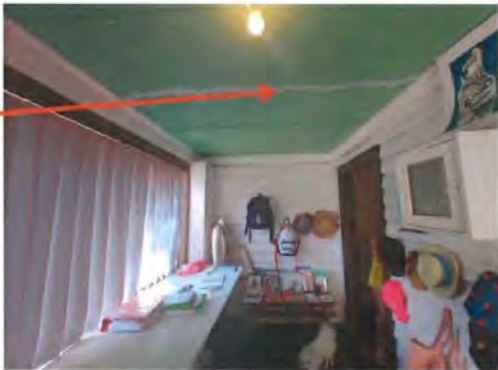
ENCLOSED VERANDA - ENTRANCE

Cracked and sagging
ceiling panels

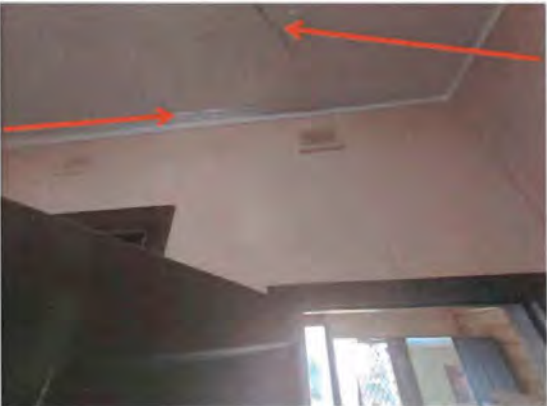
MAIN BEDROOM

Poor fitting wall panels

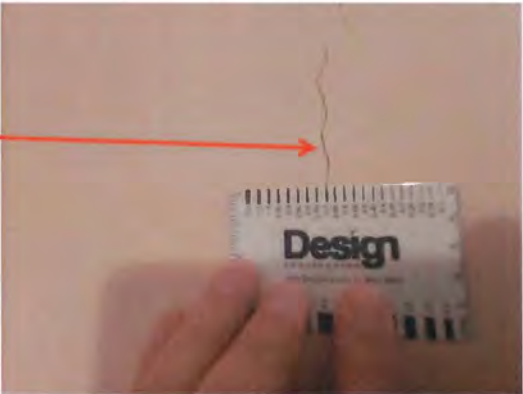
MAIN BEDROOM

Cracked ceiling panel

Crack measure

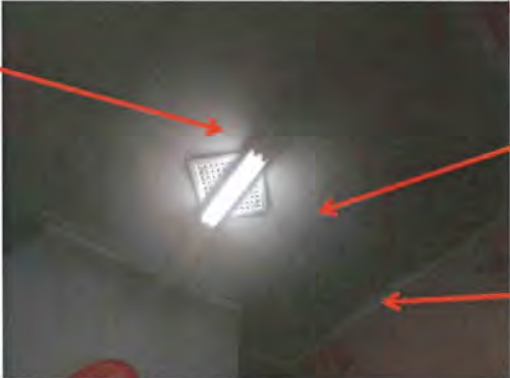
LOUNGE – CEILING

Depressed ceiling

Panel cracks

Poor fitting
ceiling & wall
panels

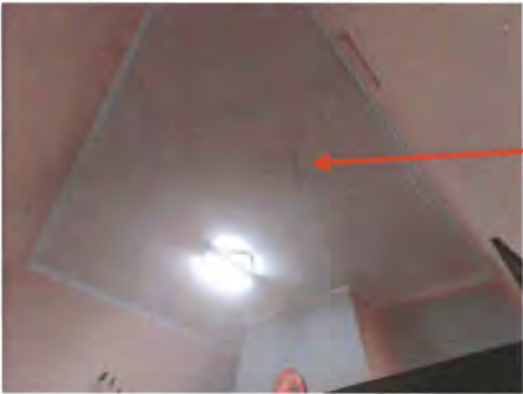
LOUNGE – CEILING

Panel crack

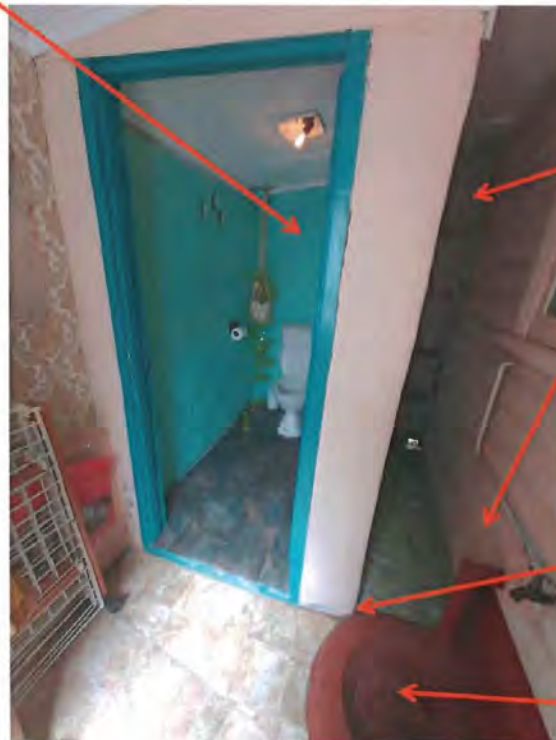
Missing cross vent inside cubicle

Enclosed cross
ventilation

Missing sewer
vent

The toilet chamber is missing cross ventilation leading to outside air

The enclosure of the gulley and missing vent pipe may prove to be a health hazard.

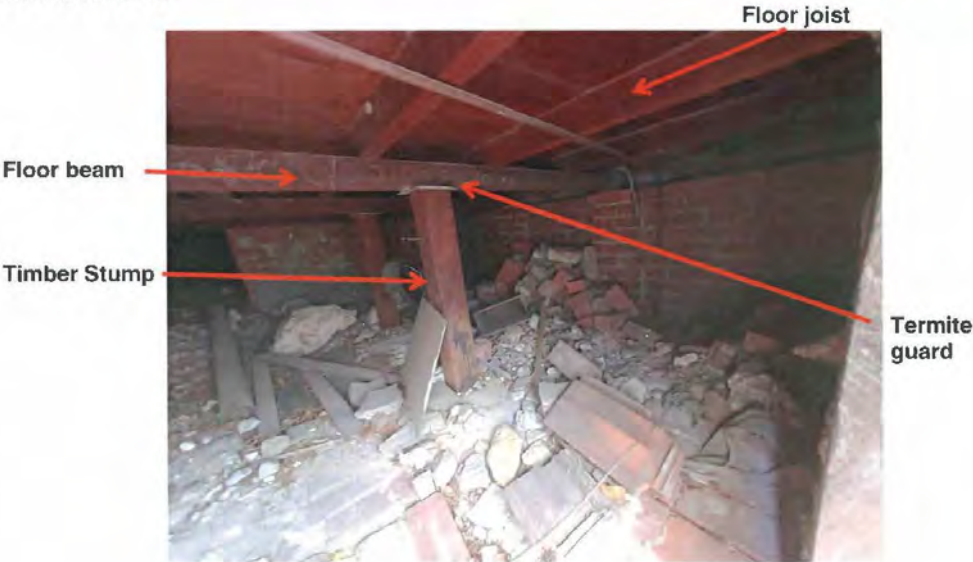
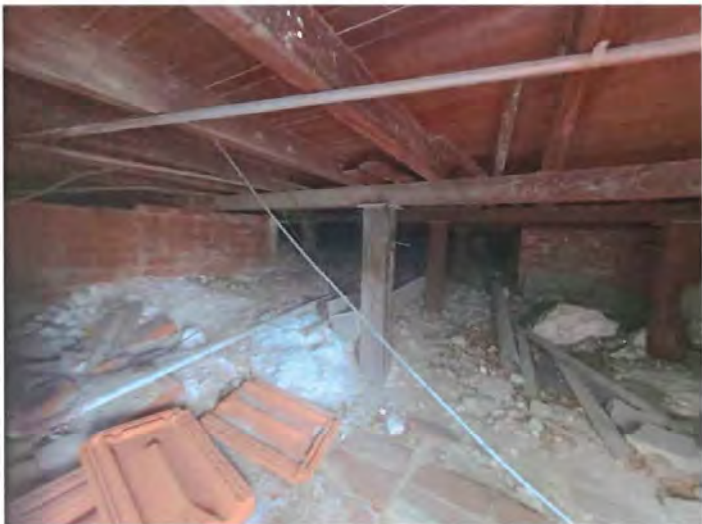
FOUNDATIONS

The foundations to the house are **not** showing any signs of subsiding. There are cracks in the wall and ceiling panels around doorways and where extensions to the house have been carried out.

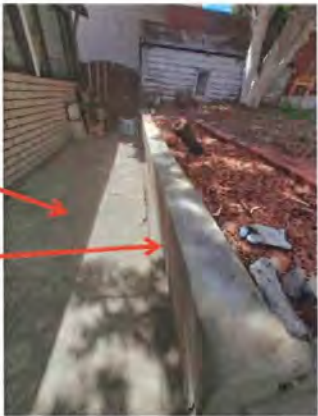
RETAINING WALL – BACK YARD

The brick retaining walls to the walkways at the rear of the house are cracked in several places and do not meet Building Standards.

Cracked paving

Out of plumb wall

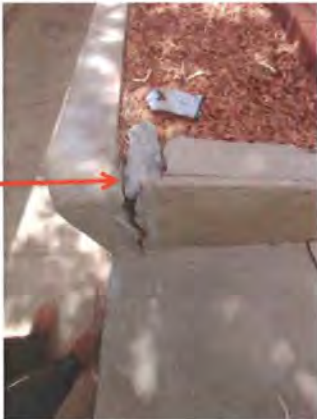
RETAINING WALL – BACK YARD

Damaged wall

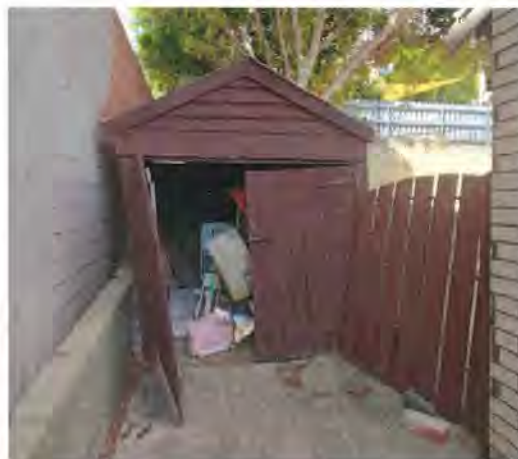
GARAGE - REDUNDANT

The timber outbuilding forming the garage is obsolete and redundant

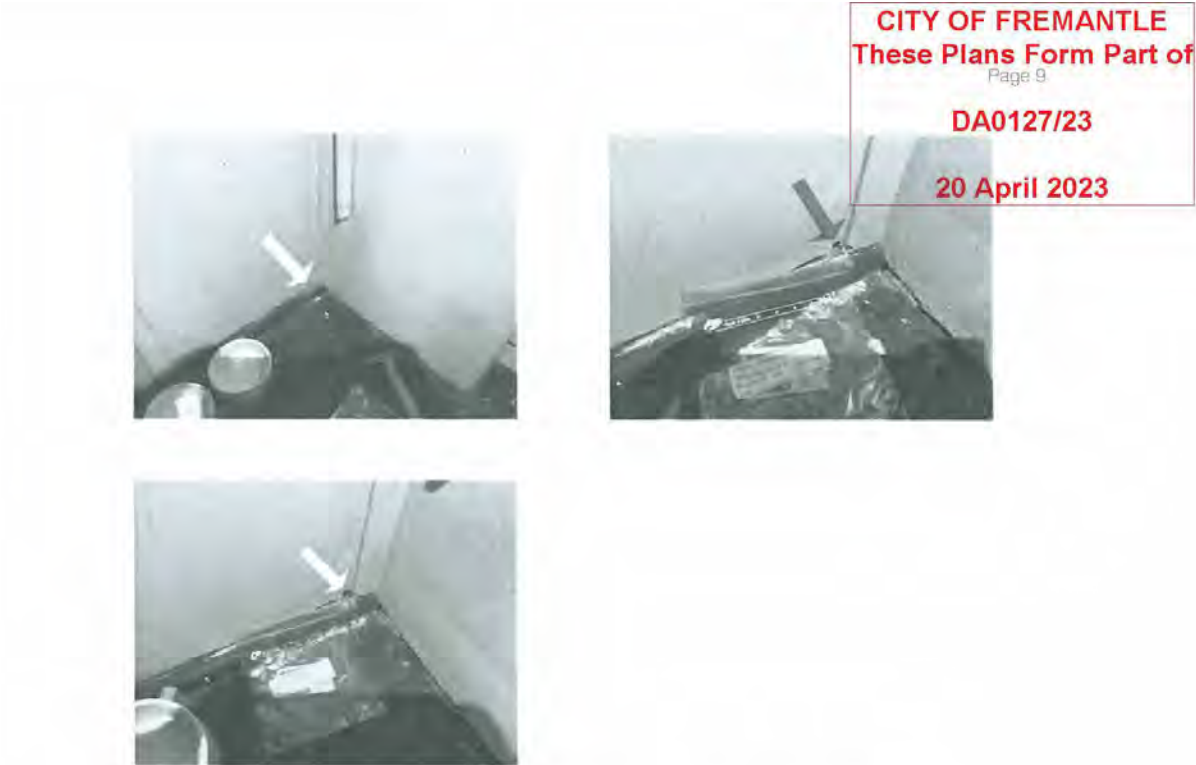
Building: Main Building
Location: Kitchen
Finding: ACM Suspected Wall Sheets - Sample# 001
Information: The bottom wall panel under the shelf to the left of the entrance to the kitchen (from the main entrance) are suspected to have been constructed with the use of asbestos-containing materials (ACM). The observable area of wall sheeting appear to have no obvious signs of damage or deterioration, indicating that the asbestos is currently encapsulated and contained. Damaged and deteriorated ACMs have a higher probability of releasing airborne asbestos fibres, creating a significant health safety risk.

Where the client elects to retain the ACM, the client should regularly monitor the condition of the wall sheets to identify any further damage or deterioration. Such monitoring should be conducted at least annually, but more frequently should damage or evidence of deterioration occur.

No works should be carried out to the ACM or associated building elements without further specialist advice.

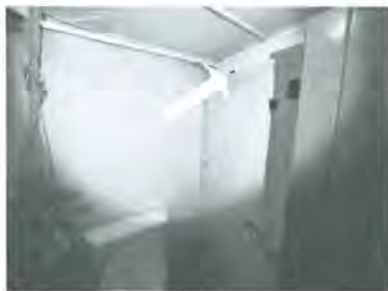
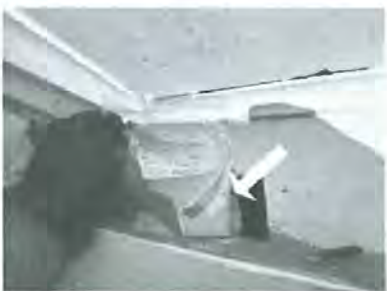
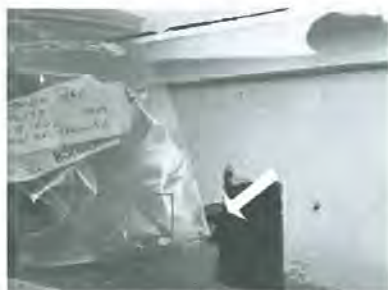
Asbestos, Asbestos Containing Materials and Asbestos Dust 4.03

Building: Main Building
Location: Toilet
Finding: ACM Suspected Wall Sheets - Sample# 002
Information: Walls throughout the toilet outside the kitchen towards the rear of the building are suspected to have been constructed with the use of asbestos-containing materials (ACM). Sections of the wall sheets appear to be in poor condition, showing evidence of damage and deterioration. Damaged and deteriorated ACMs have a higher probability of releasing airborne asbestos fibres, creating a significant health safety risk.

Where the client elects to retain the ACM, the client should regularly monitor the condition of the wall sheets to identify any further damage or deterioration. Such monitoring should be conducted at least annually, but more frequently should damage or evidence of deterioration occur.

No works should be carried out to the ACM or associated building elements without further specialist advice.

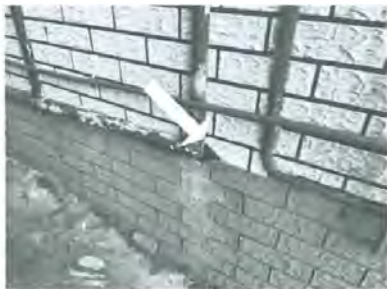
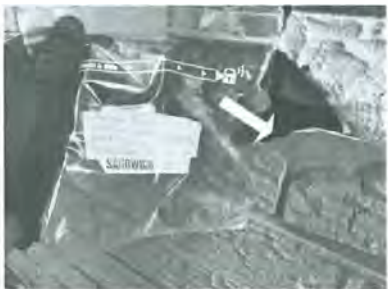
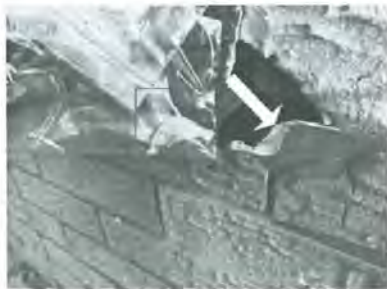
Asbestos, Asbestos Containing Materials and Asbestos Dust 4.04

Building:	Main Building
Location:	All External Areas
Finding:	ACM Suspected Artificial or Fake Brick Cladding - Sample# 003
Information:	<p>Several forms of artificial or fake brick 'look' cladding materials contain Asbestos. At the time of the inspection, the observable areas of the cladding appear to subject to damage and deterioration and/or points of attachment or fixings appear to be in an unsealed condition.</p> <p>Damaged and deteriorated ACMs have a higher probability of releasing airborne asbestos fibres creating a significant health safety risk.</p> <p>Sample# 003 was taken from the fake brick cladding for lab analysis to confirm the presence of asbestos. See associated photos for more details. The results from the lab tested positive for asbestos. Chrysotile Asbestos and Amosite Asbestos were detected.</p> <p>In the interim, any damaged or deteriorated areas should be isolated, with consideration given to potential interim remedial works, such as the application of</p>

The external fake brick cladding and the wall panel in the toilet do show signs and damage and deterioration to the material. This will increase the risk of airborne fibres. The client is advised to act with caution around these areas and seal exposed areas where possible.

sealants to limit the release of airborne fibres by appropriately qualified tradespeople.
Removal by a Licensed Asbestos Removal firm would be advised.

No works should be carried out to the ACM or associated building elements without further specialist advice.

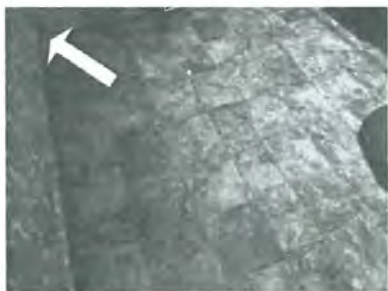
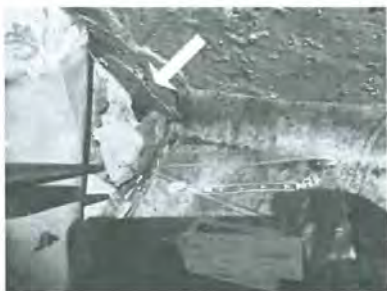
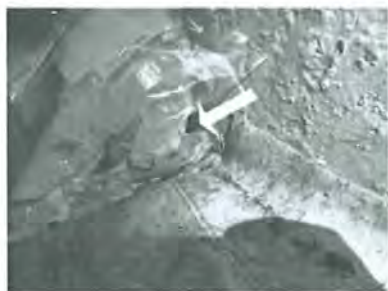
Building:	Main Building
Location:	Toilet outside room
Finding:	ACM Suspected Wall Sheets - Sample# 004
Information:	<p>Walls throughout the toilet outside the kitchen towards the rear of the building are suspected to have been constructed with the use of asbestos-containing materials (ACM). Sections of the wall sheets appear to be in poor condition, showing evidence of damage and deterioration. Damaged and deteriorated ACMs have a higher probability of releasing airborne asbestos fibres, creating a significant health safety risk.</p> <p>Sample# 004 was taken from the bottom right corner of the wall panel for lab analysis to confirm the presence of asbestos. See associated photos for more detail. The results from the lab tested positive for asbestos. Chrysotile Asbestos and Crocidolite Asbestos were detected.</p> <p>When the client want to remove the panel for what ever reason removal by a Licensed Asbestos Removal firm would be advised.</p>

Where the client elects to retain the ACM, the client should regularly monitor the condition of the wall sheets to identify any further damage or deterioration. Such monitoring should be conducted at least annually, but more frequently should damage or evidence of deterioration occur.

No works should be carried out to the ACM or associated building elements without further specialist advice.

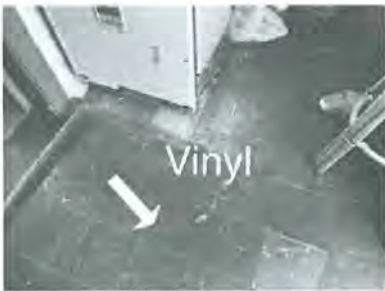
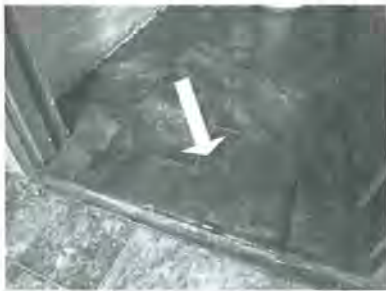
Vinyl floor covering may have several asbestos containing materials (ACM), including within the vinyl body of the tiles/sheeting, as a fibrous backing to the tiles, or as an asbestos-based adhesive used to fix the tiles to the adjoining floor. At the time of the inspection, the observable areas of vinyl flooring appear to be free of damage or deterioration. Damaged and deteriorated ACMs have a higher probability of releasing airborne asbestos fibres, creating a significant health safety risk.

The panel at the main entrance indicated by the photos should also be considered to contain asbestos.

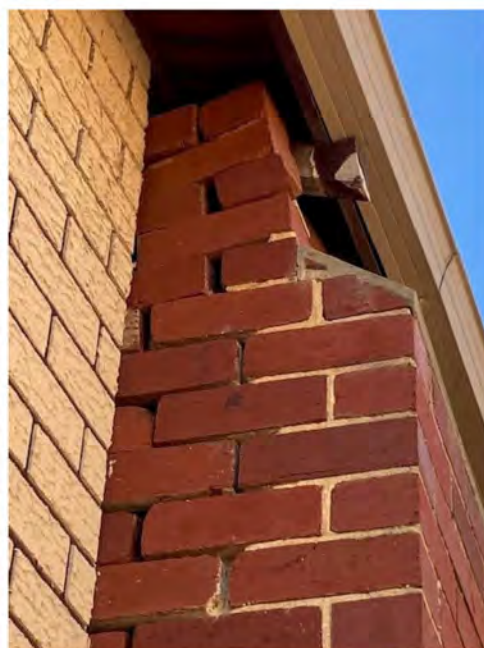
Brick chimney with deteriorated pointing, south wall.
