# North Fremantle Foreshore Management Plan 2013

## EXECUTIVE SUMMARY

The purpose of the North Fremantle Foreshore Management Plan is to address the above and provide guidance on future management and design decisions for the foreshore. This document aims to provide a workable document that is accessible for decision makers, contractors and community members.

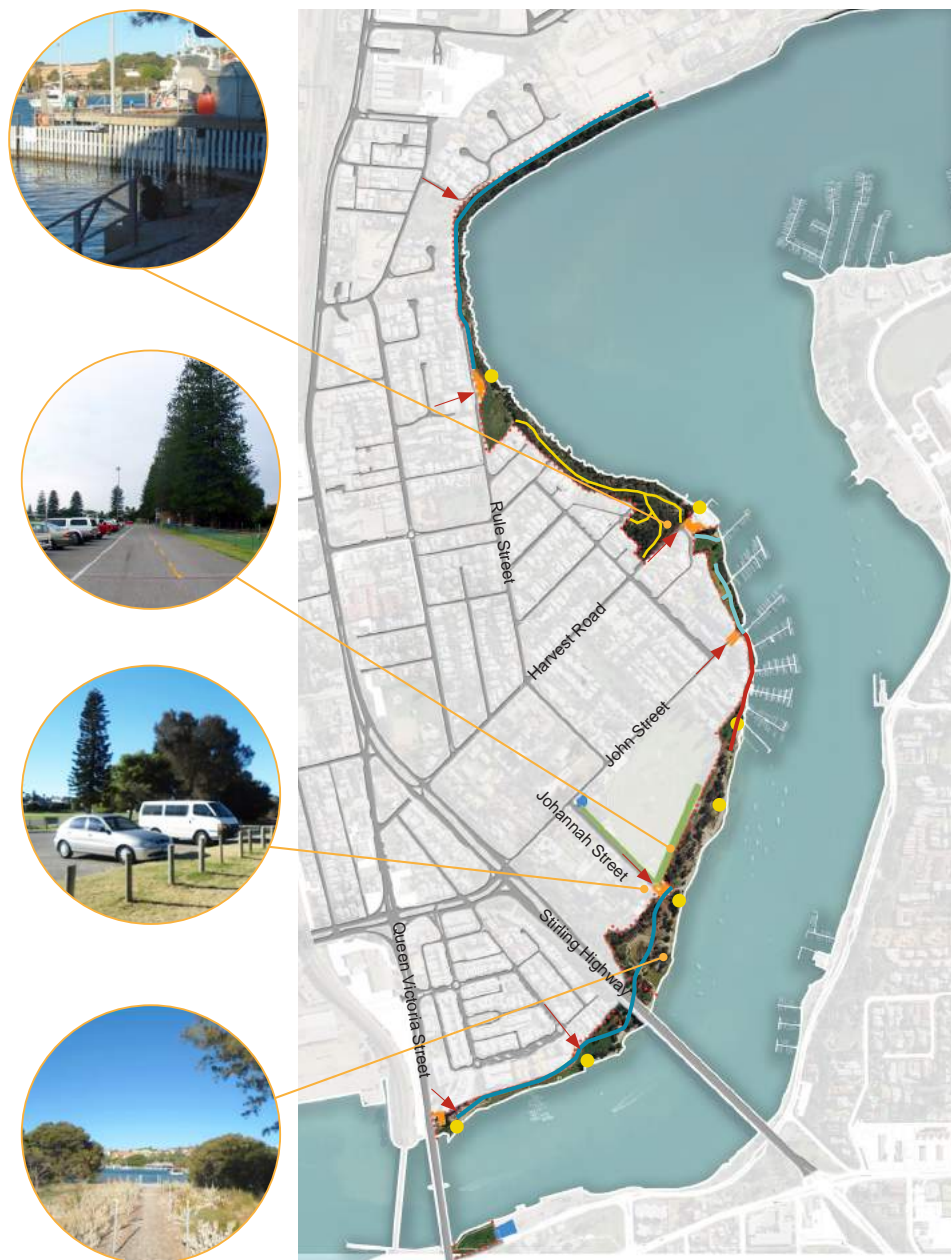
Figure 1: Access and Circulation

Access along the foreshore is provided by path networks that vary in form, texture and experience. Figure 1 shows current path networks and surface finishes for the paths.

The Heritage Trail between Rule Street and Harvest Road consists of a narrow footworn track which meanders along at cliff top level. The track surface generally consists of sand, loose limestone rubble and limestone caprock. Some parts of the trail are easy to walk on whilst others are more difficult, particularly on steep gradients and jagged surfaces (see figure 1)

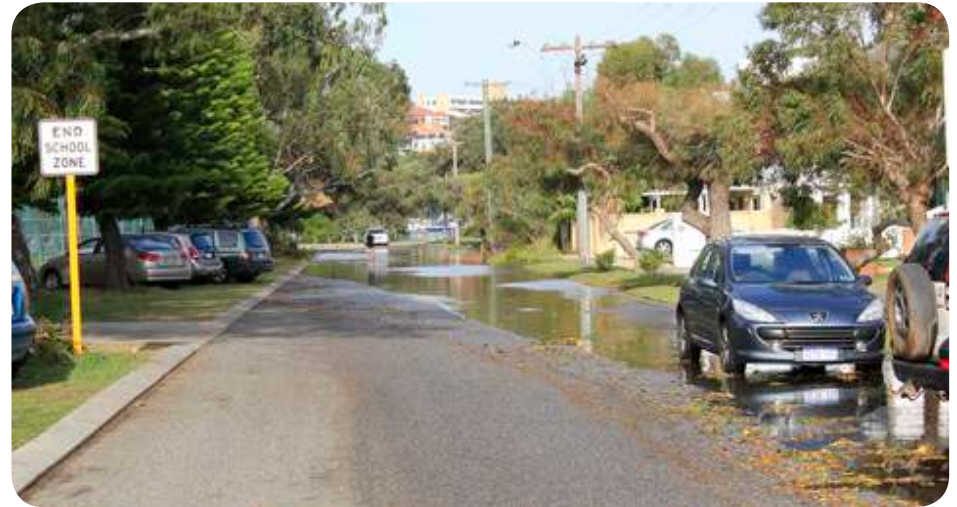
24. Flooded streets due to high tides, storm surge and aging drainage infrastructure

Seasonal storm surges cause significant damage to the foreshore and an analysis of the tidal records at Fremantle indicating that storm surges can exceed 1 metre along the North Fremantle foreshore. As depicted in early photographs, the area's most susceptible to flooding support a range of intertidal/riparian flora able to 'buffer' or 'soften' a storm surge, however, much of this original landscape type has been lost through reclamation during the 1960's and has altered the shorelines biodiversity and ability to buffer from tides and storm surges.

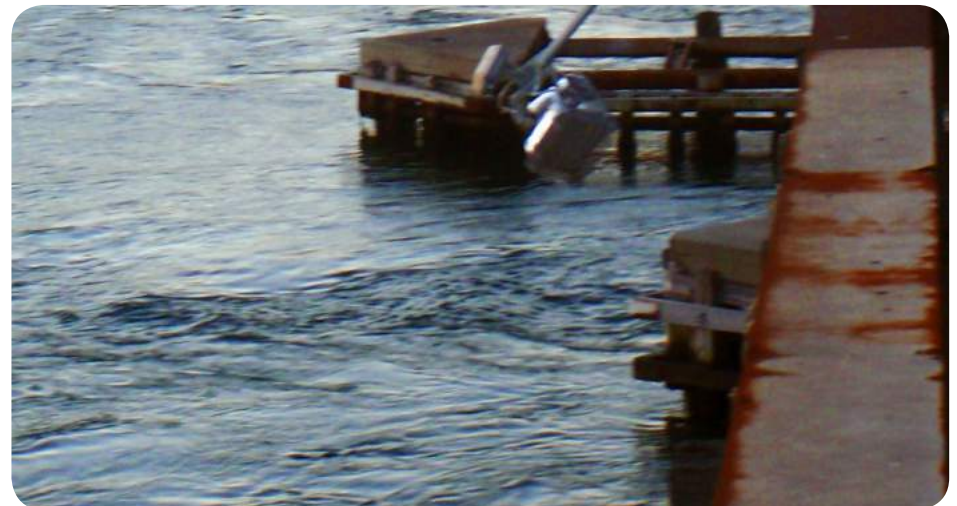
25. Tidal flow currents at Fremantle Traffic Bridge

The hydrodynamics of the Swan River are dominated by the tides and winter rainfalls. Stream flow is normally between 2 to 5 million cubic metres per day in winter, but can peak at over 15 million cubic metre per day which generates strong river currents along the North Fremantle foreshore. This can cause extreme conditions for swimmers and inexperienced sailors.

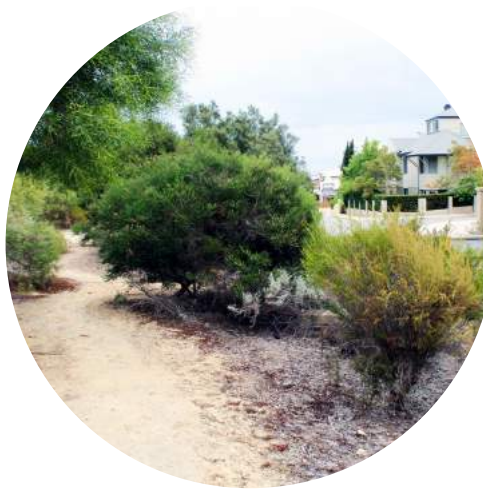
43. Restoration area, Cypress Hill

Recent site visits have shown restoration planting to be growing in zones as determined during planting. These zones attempt to mimic pre-settlement vegetation types. Surviving species have begun forming distinct 'communities' characterised by dominant species and localised environmental conditions. Restoration efforts have revealed that altered soils within the NFFMP boundary are not capable of supporting the entire palette of species that would have naturally occurred in the area.

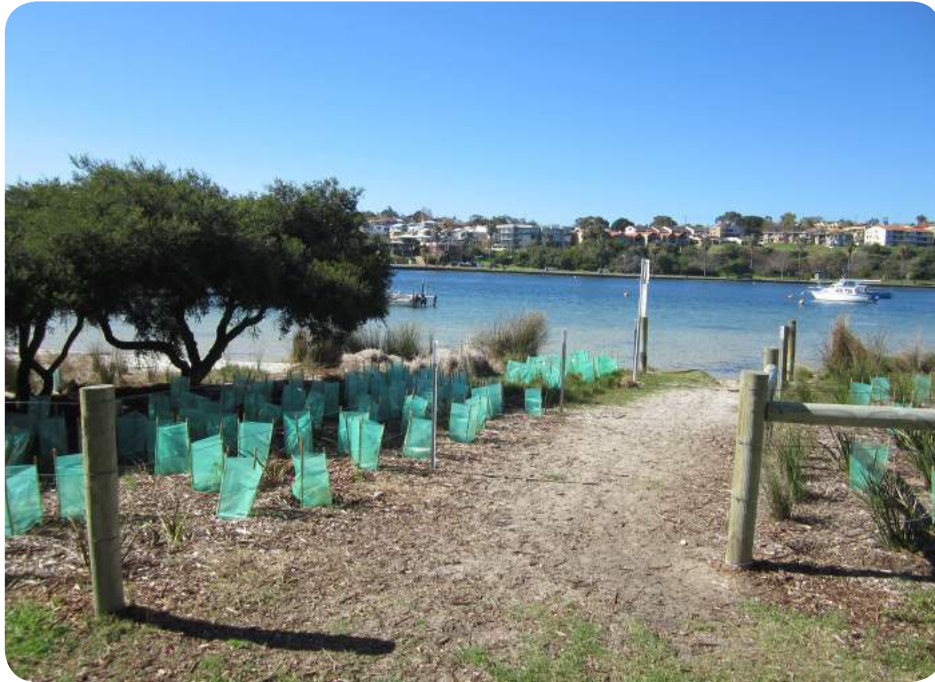
45. Revegetation, Johannah Street Reserve

This typology can be seen at Cypress Hill and along the Johannah Street Foreshore and is composed of colonising and resilient species, able to survive in difficult conditions. Such species include:

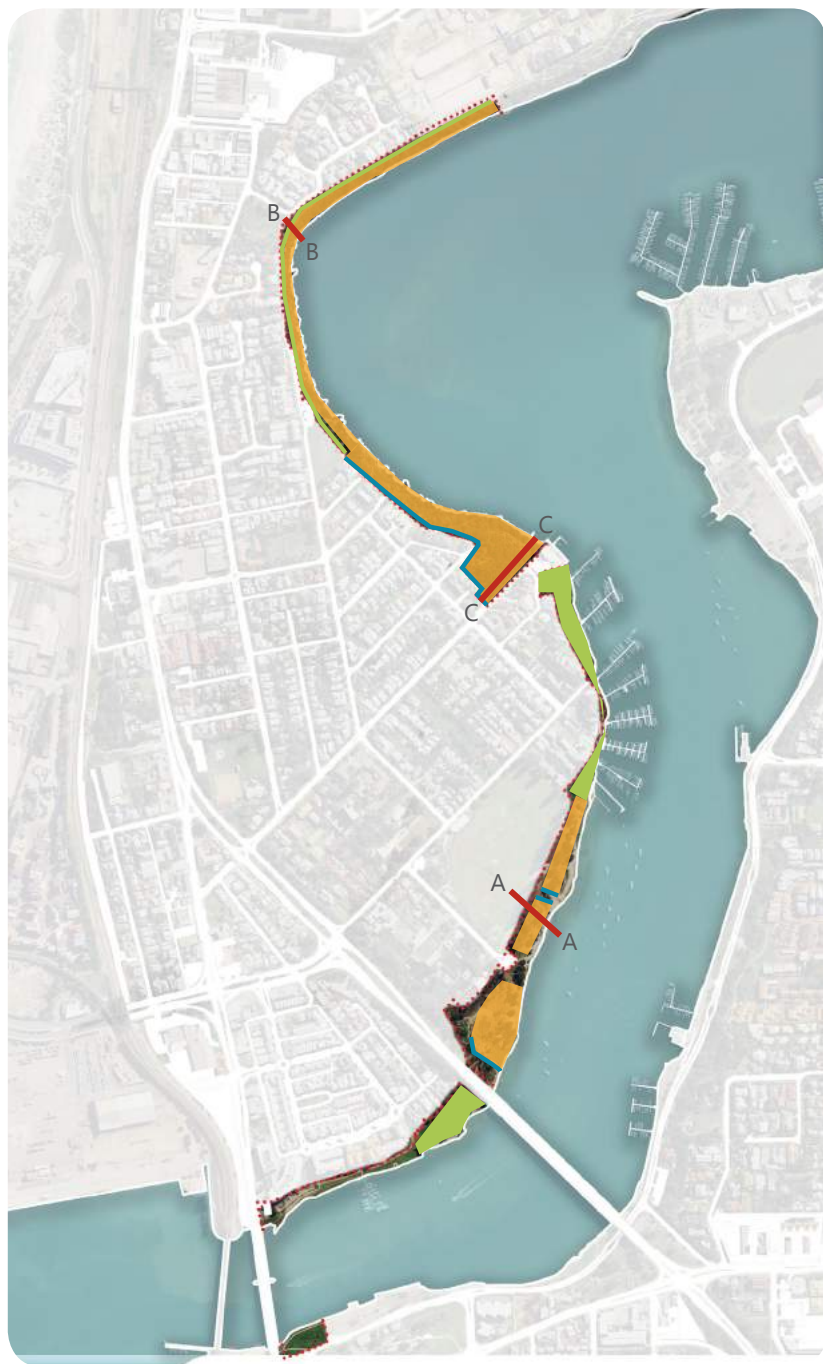
AA| Johannah Street Foreshore/ Gilbert Fraser Reserve

There is a strong correlation between weed infestation and condition of the native vegetation. Recent site visits have shown weeds species are most commonly present adjacent to paths and along private property boundaries.

Blue line: Weed edges

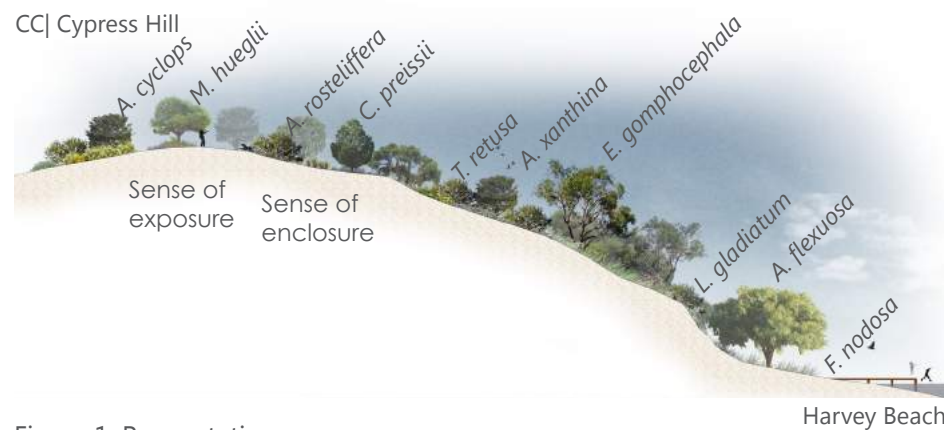
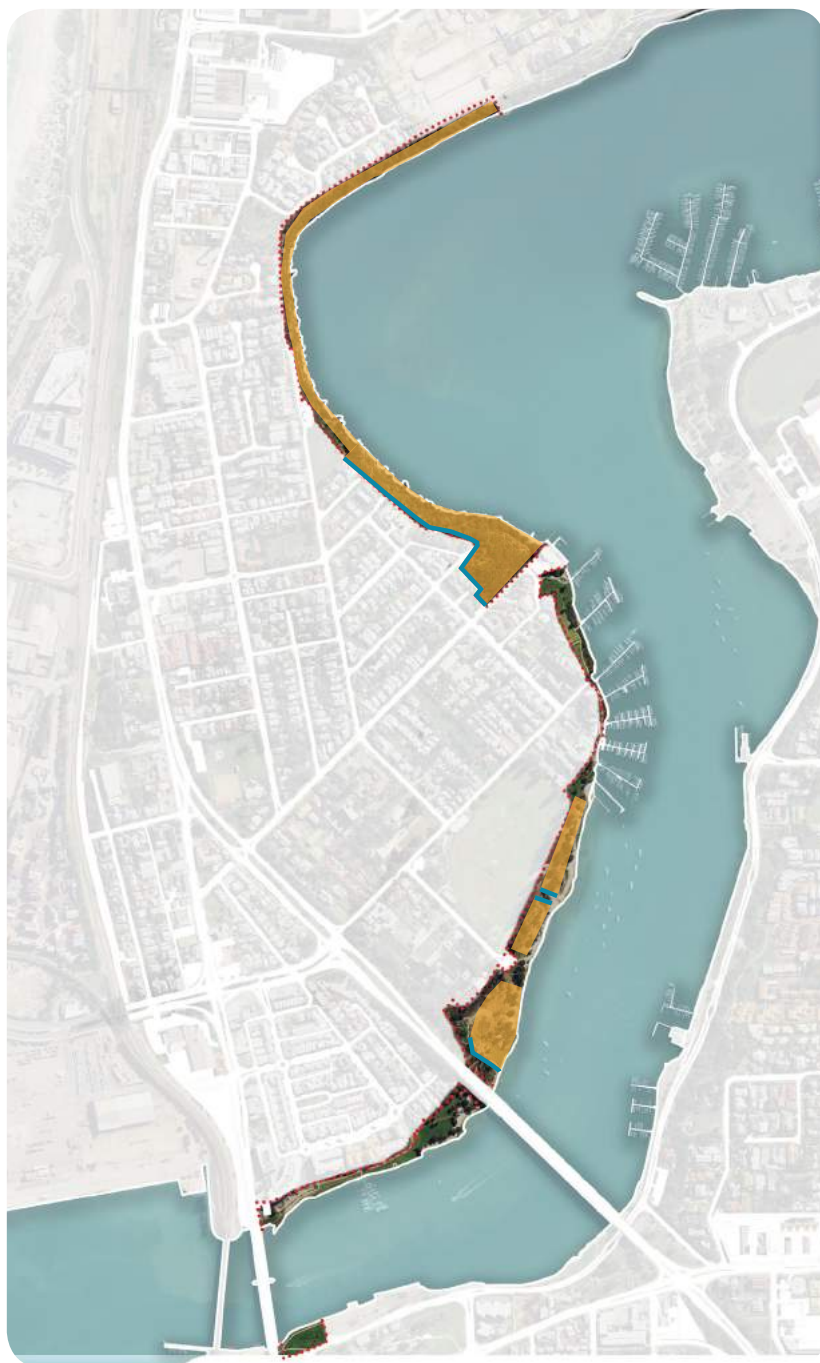
Figure 1: Revegetation areas

Orange square: Revegetation and Restoration area

Red dotted line: NFFMP and Swan River Trust Development Control Area boundaries

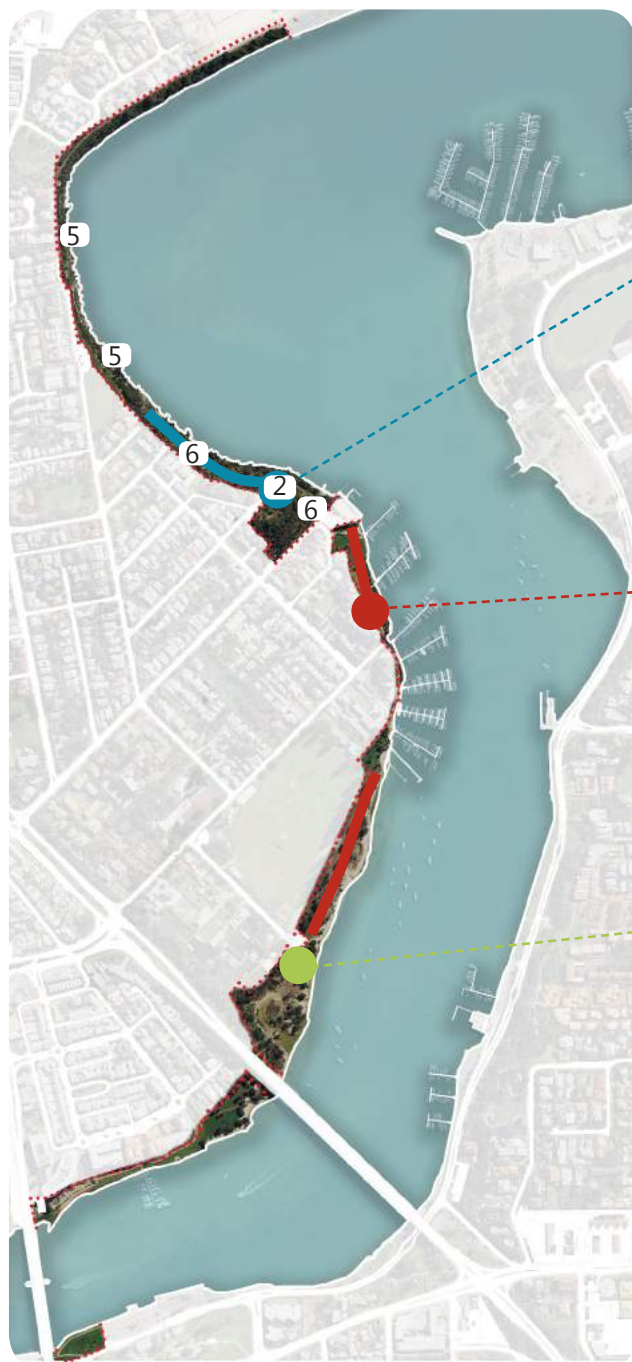
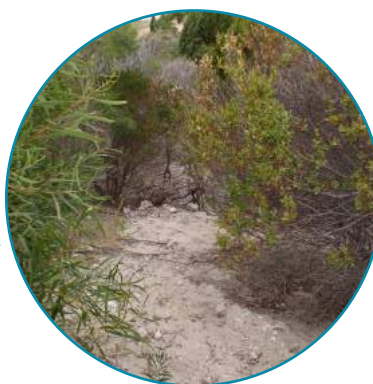
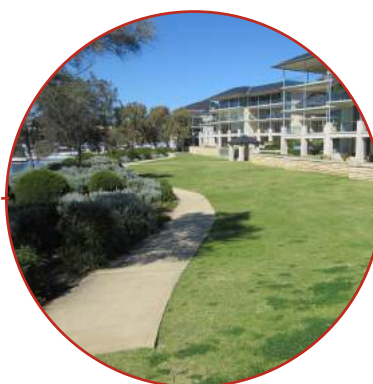
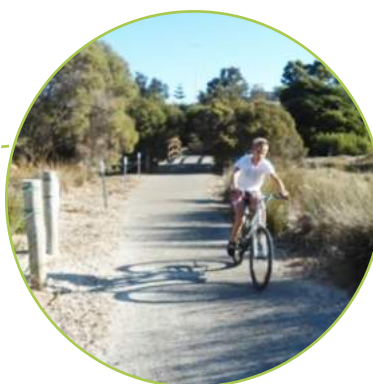
- Requires upgrade and maintenance
- Path extension required
- Adequate

- Path hierarchy is vague
- Limited access to Rocky Bay beaches has caused unstable paths to form down Rocky Bay cliffs.
- Goat tracks deviating from original routes within bushland are causing erosion and unsafe conditions.

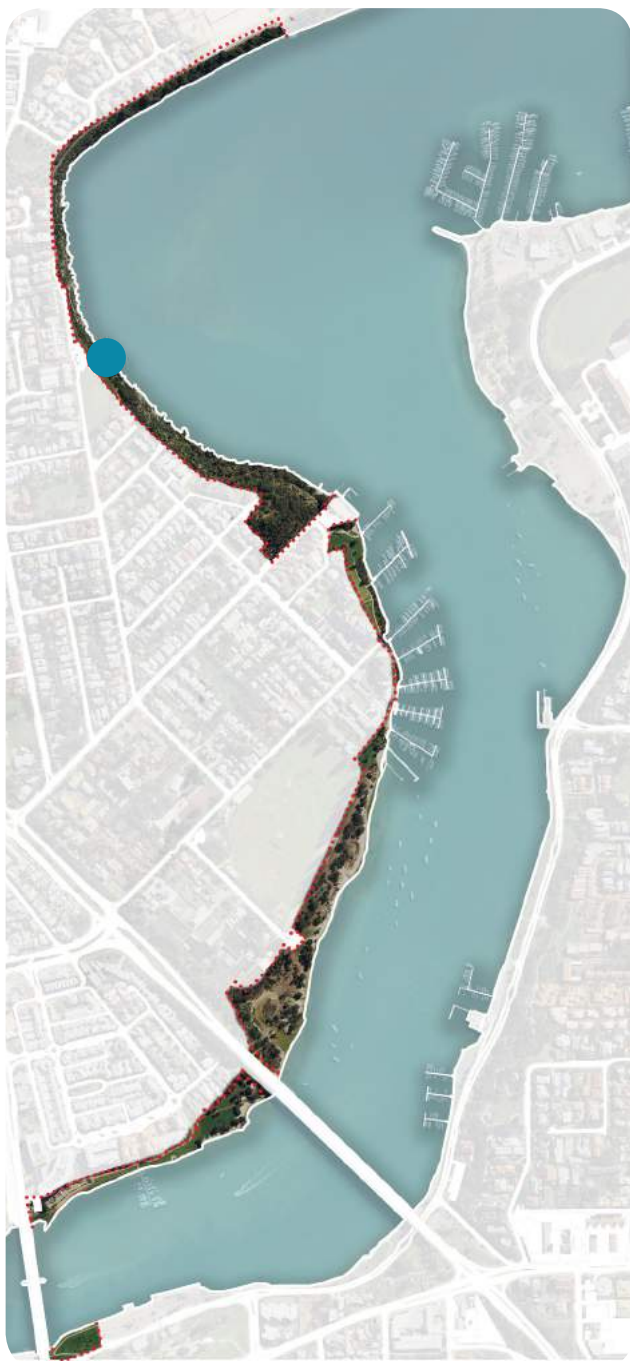
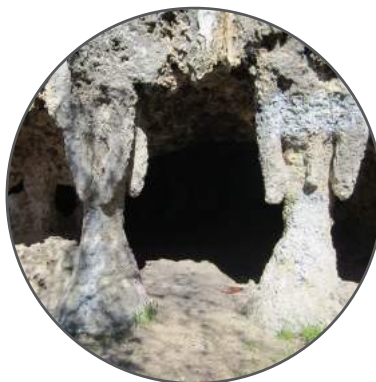
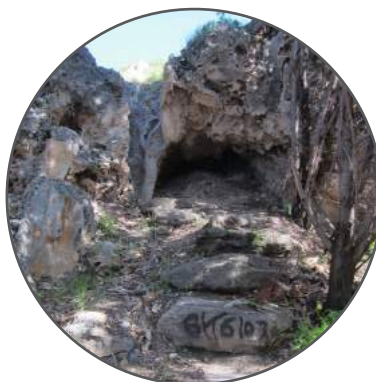
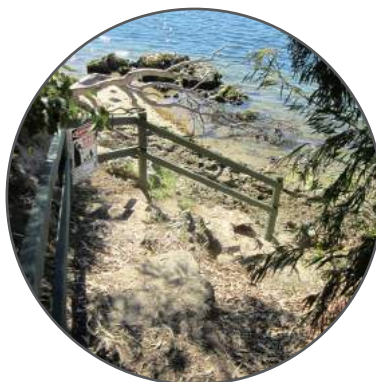
● Requires upgrade and maintenance

Garangup Caves are currently accessible to the public and are being used anti-socially. This causes concerns to residents regarding safety of children and property. Aboriginal heritage value is also major issue of this site.

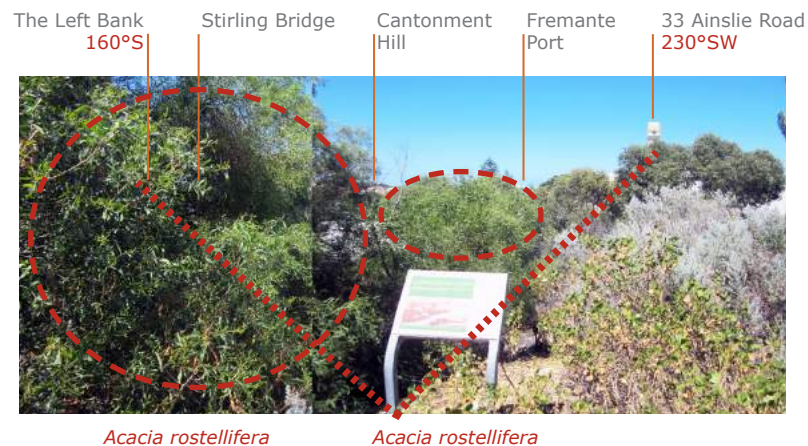
### Viewpoint 1

Taken from in front of sign  
 S 32°01.842' E 115°45.499'  
 Elevation 29m  
 View window 160°S - 230°SW

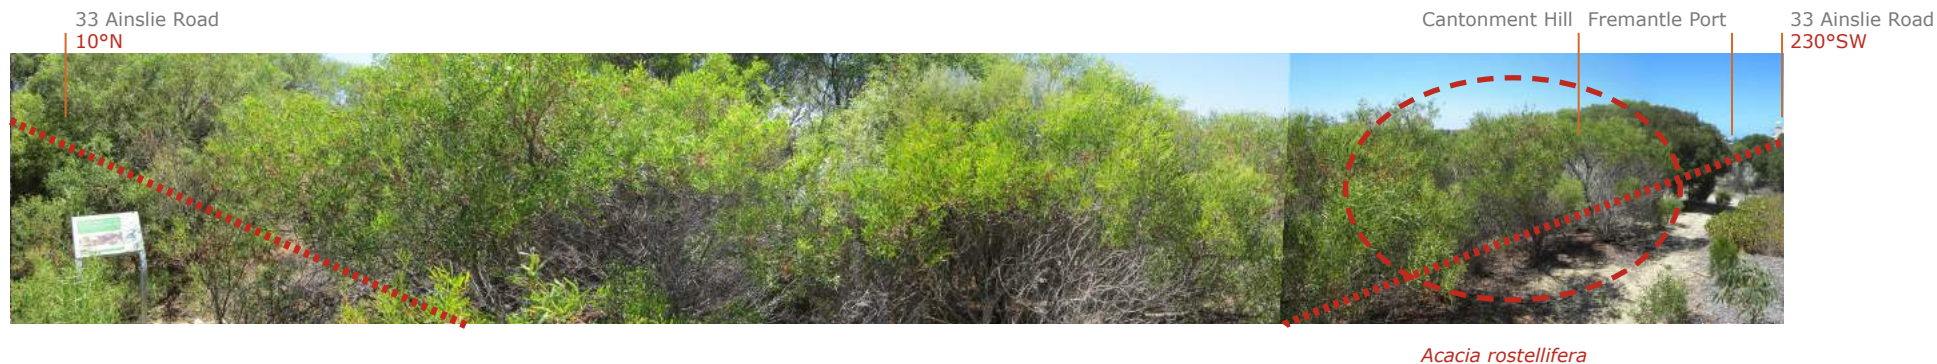
### Viewpoint 2

Taken from limestone slab  
 S 32°01.842' E 115°45.499'  
 Elevation 28m  
 View window 10°N - 230°SW

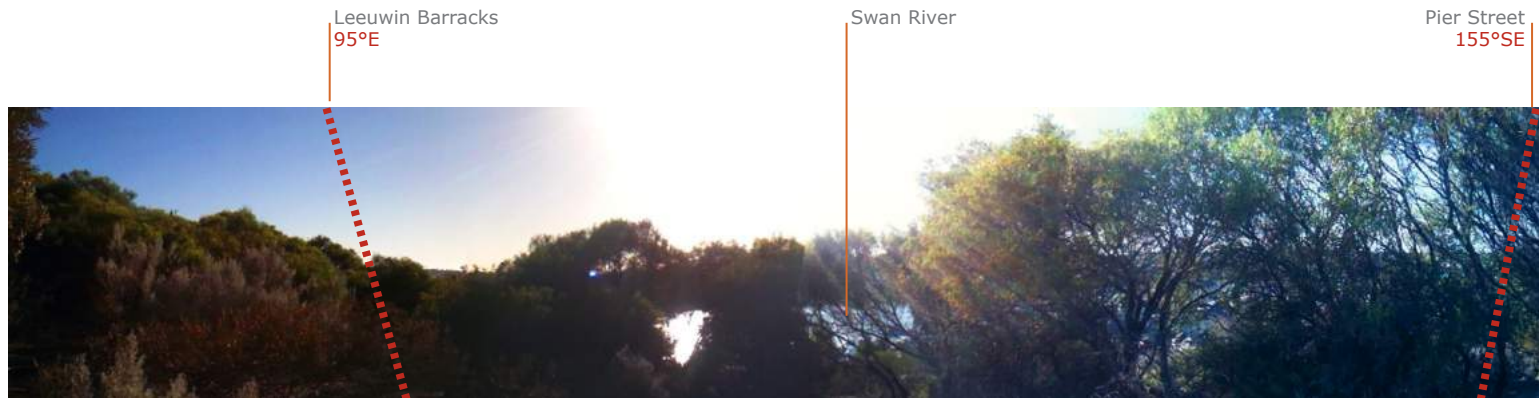
### Viewpoint 3

Taken from limestone slab  
S 32°01.831' E 115°45.507'  
Elevation 28m  
View window 95°E - 155°SE

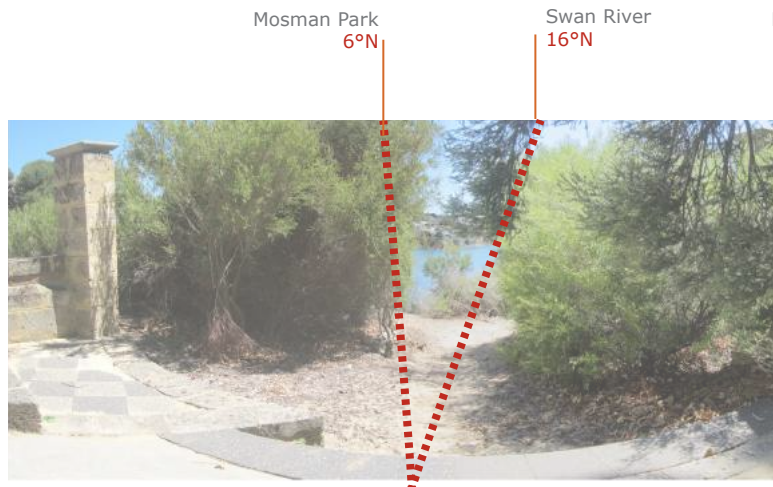
### Viewpoint 4

Taken from bench seat  
S 32°01.807' E 115°45.443'  
Elevation 34m  
View window 325°NW - 40°NE, 6°N - 16°N visible

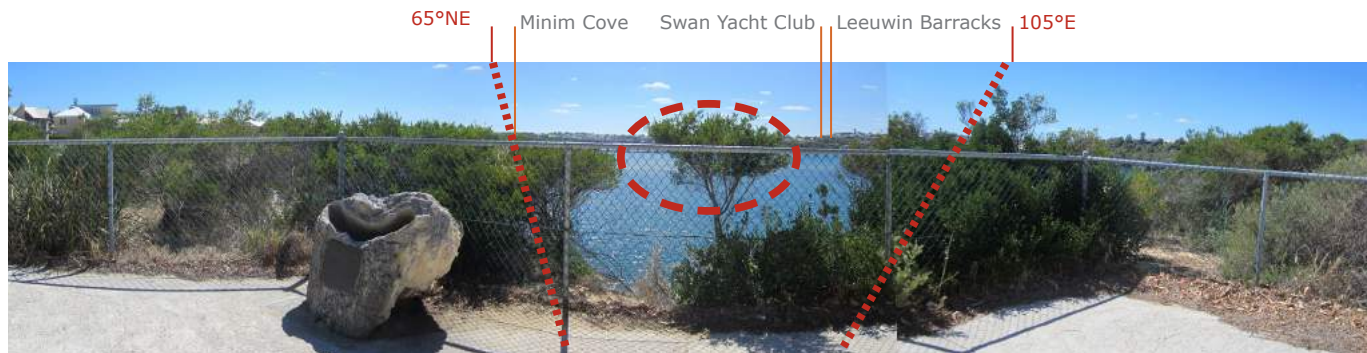
### Viewpoint 6

Taken from bench seat  
 S 32°01.628' E 115°45.307'  
 Elevation 17m  
 View window 15°N - 150°SE

*Templetonia retusa*

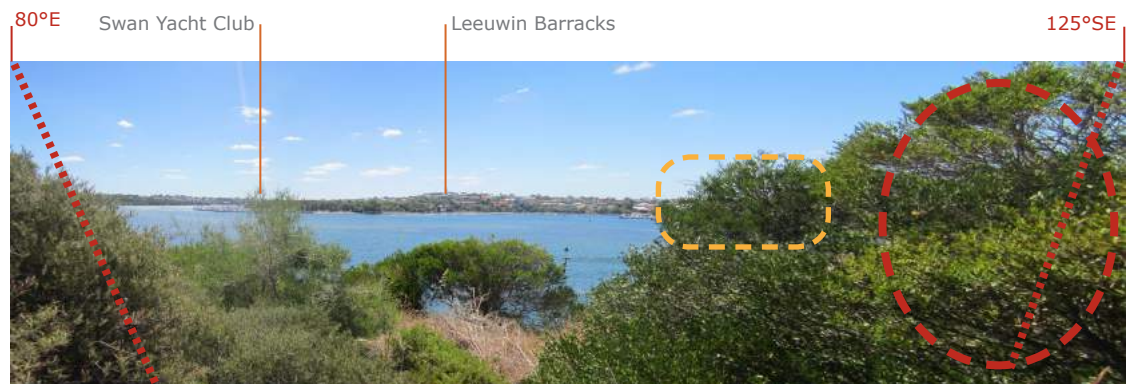
### Viewpoint 8a

Taken from bench seat  
S 32°01.543' E 115°45.309'  
Elevation 11m  
View window 60°NE - 170°S

*Templetonia retusa*

*Acacia rostellifera*

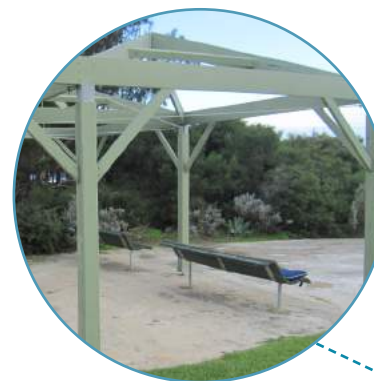
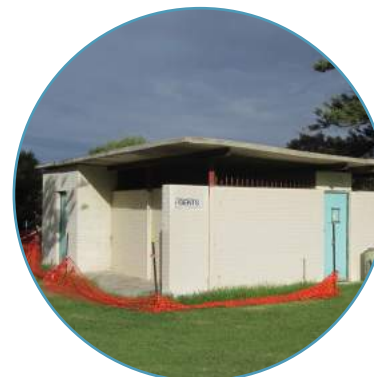
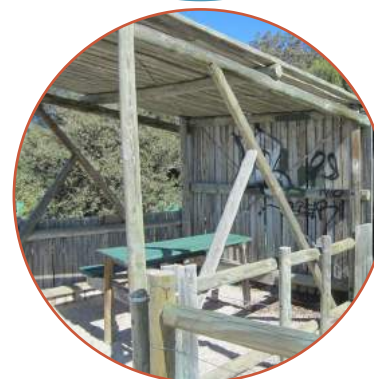
Structures within the North Fremantle foreshore are generally in poor condition. Treated pine shelters are rotting, falling apart and are hubs for antisocial behaviour. The condition of the shelters epitomise residents view of the North Fremantle foreshore being poorly managed and left to rot.

- Requires upgrade and maintenance
- New structure opportunity

1. Undertake an inventory to assess quality of structures and appropriateness of location.
2. Refurbish or replace picnic structures, with an updated suite of typologies and materials.
3. Revisit public toilet situation and consider long term plan for ablution facilities. Consider 'eco toilets'.
4. Provide roofing for John Street reserve pergola for protection from elements.

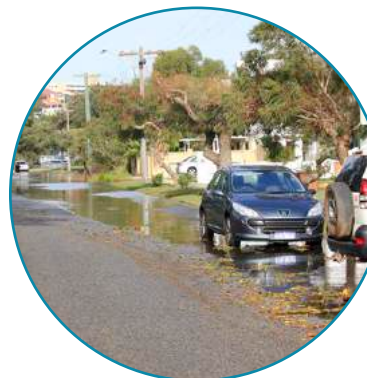
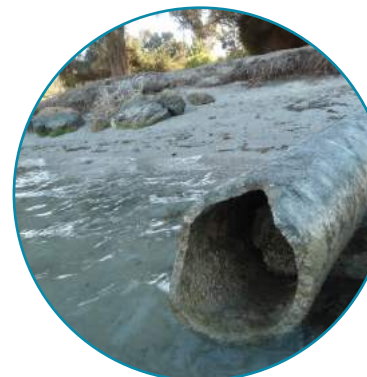
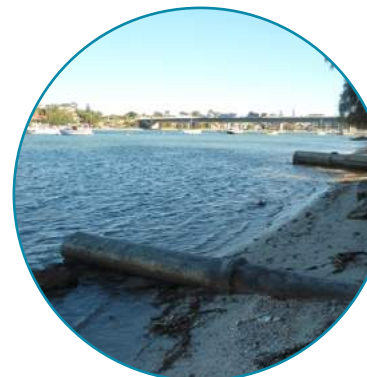
Requires upgrade and maintenance

1. Undertake study of existing drainage system in collaboration with Water Corporation.
1. Liaise with Water Corporation to ensure drainage infrastructure is adequately maintained and upgraded where required.
