Planning Committee

**PC2307-1 HERBERT STREET, NO. 21 (LOT 23), NORTH FREMANTLE -
DEMOLITION OF EXISTING SINGLE HOUSE AND INCIDENTAL
STRUCTURES (JZ DA0127/23)**

Attachment 1 - Demolition Plan & Structural Engineer Report

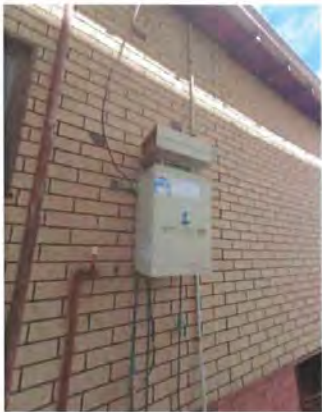
HEATING SYSTEM - NORTH WALL

Copper heating system
Fixed into cladding

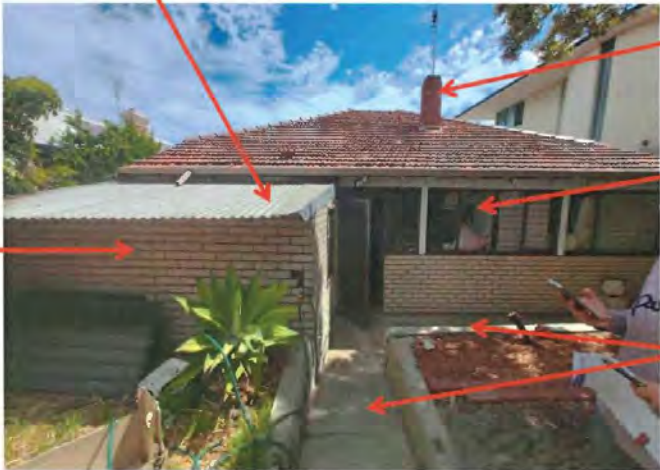
EAST WALL - BACK YARD

Chimney to Kitchen

Lean-to

Cracked paving

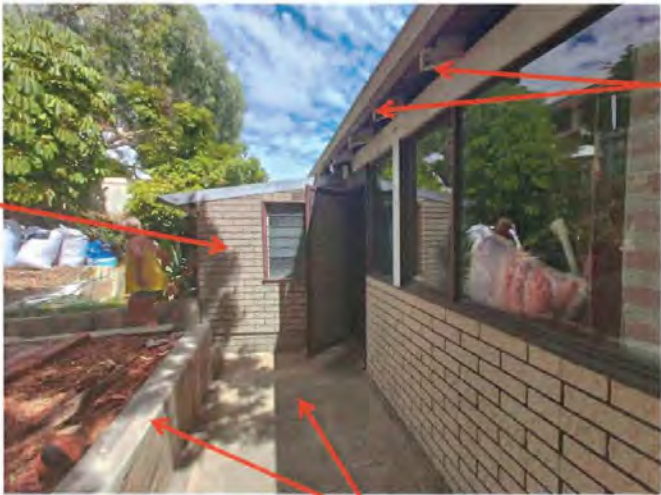
The brick retaining walls to the walkways at the rear of the house are cracked in several places and do not meet Building Standards.

Damaged rafters

Cracked and miss-align retaining walls

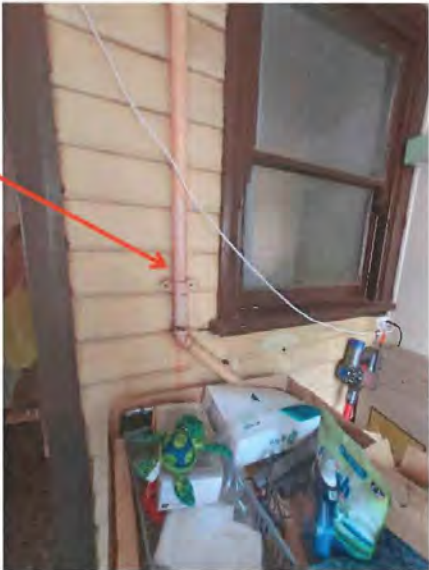
KITCHEN – LEAN-TO

Sewage vent pipe
under enclosed area

The enclosure of the gulley and missing vent pipe may prove to be a health hazard.

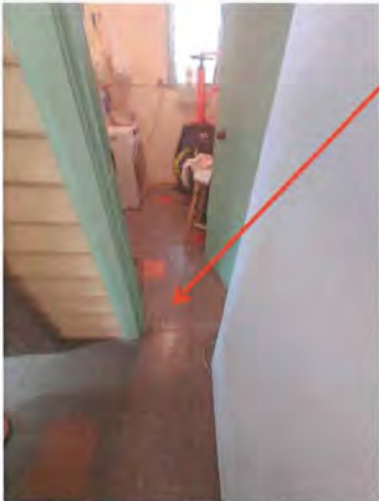
ENTRANCE TO LAUNDRY

Restricted entrance to laundry

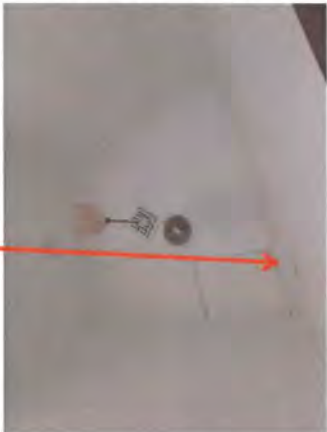
BATHROOM CEILING

Poor fitting wall & ceiling
panels

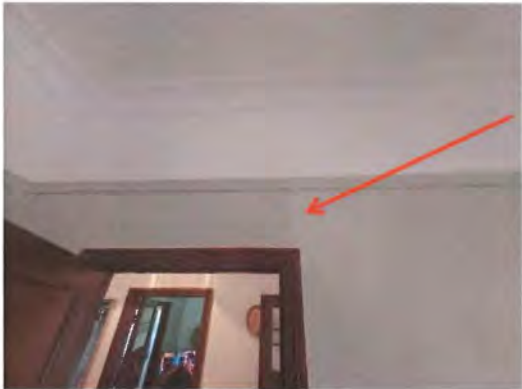
MAIN BEDROOM

Poor fitting wall
panels

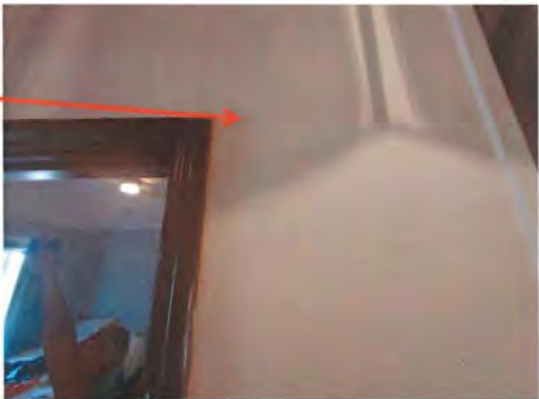
MAIN BEDROOM

Poor fitting wall panels

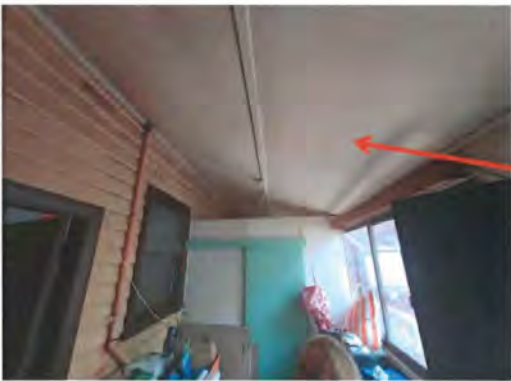
LEAN-TO – SPARE ROOM AFTER KITCHEN

Sagging ceiling

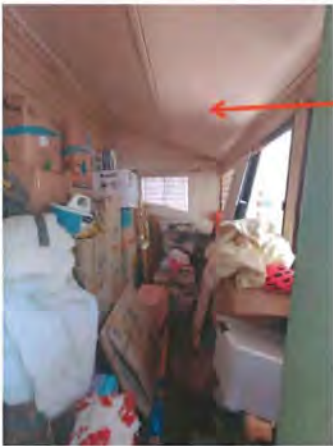
LEAN-TO – SPARE ROOM AFTER KITCHEN

Sagging ceiling

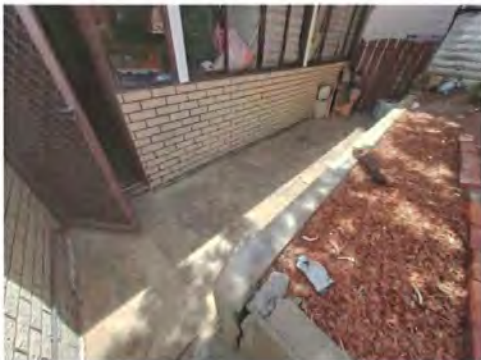
RETAINING WALL – BACK YARD

Damaged wall

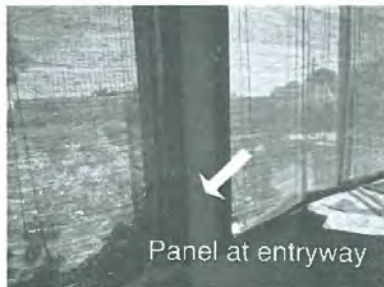
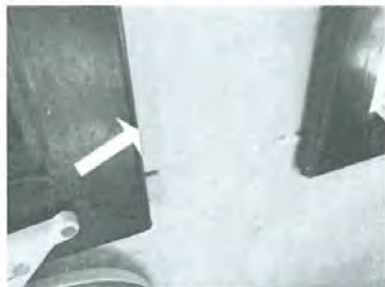
Panel at entryway

The panel at the main entrance indicated by the photos should also be considered to contain asbestos.

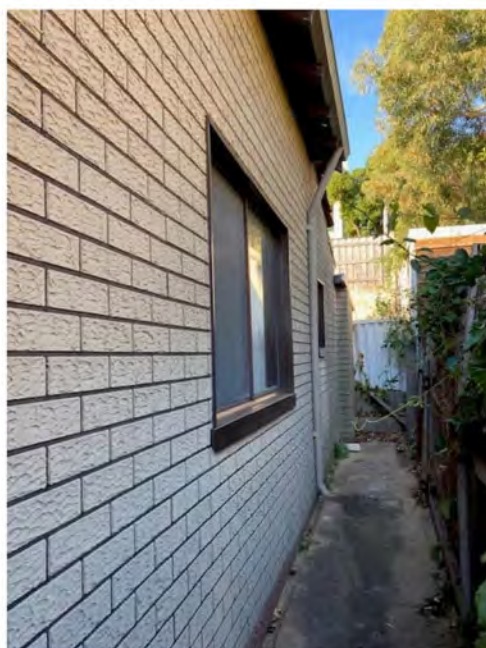
South wall of house

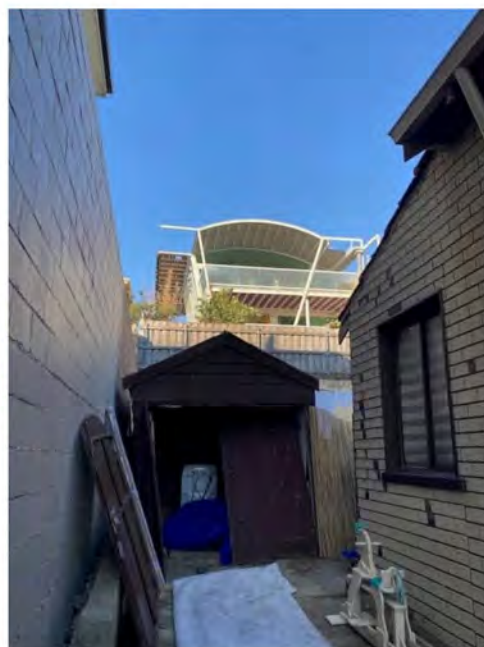
Generally, the house at 21 Herbert Street is in reasonable condition and appears to be structurally sound. Items that are in poor condition such as the Brick-Clad external wall cladding, fit-out of bathroom, kitchen and laundry have little heritage significance and can be removed / replaced without affecting the heritage value of the place. The upper section of the brick chimney on the south wall is in poor condition with eroded mortar joints. The timber shed on the north side of the house is in poor condition.

Timber shed to rear of site, north-east corner.

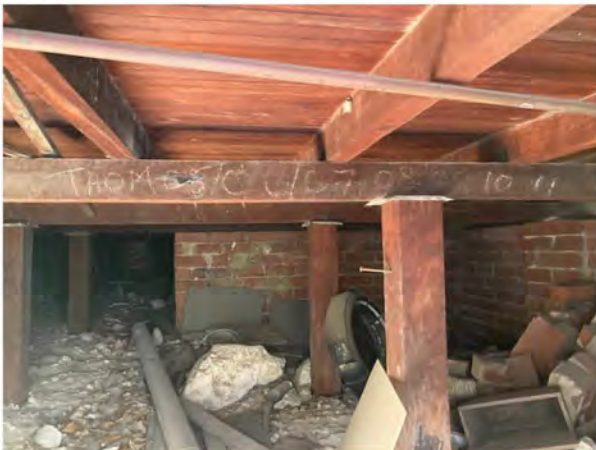
Sub-floor space showing timber floor structure and stumps

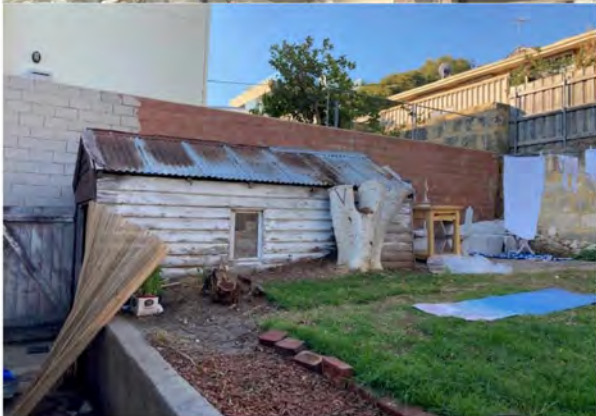
Timber Shed

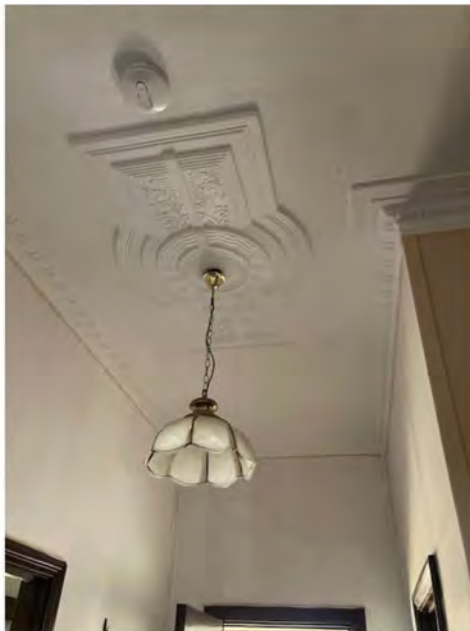
Hall ceiling

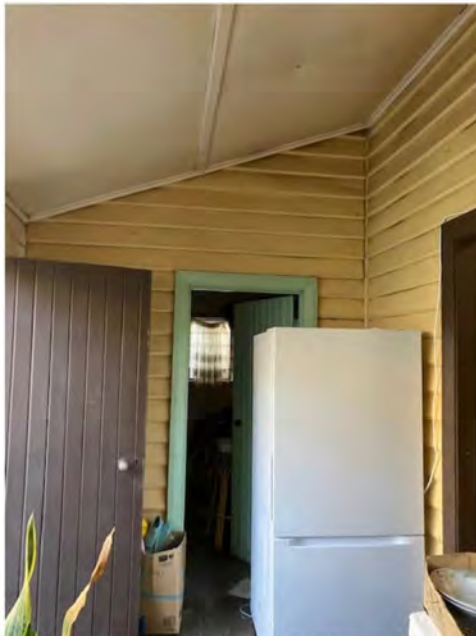
Enclosed rear verandah with original weatherboard
external wall cladding

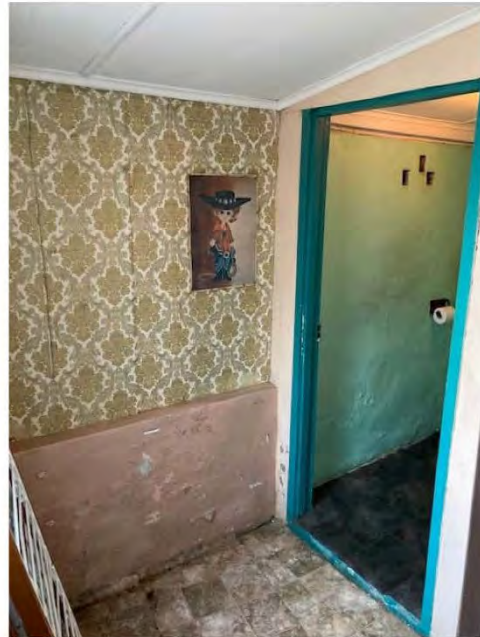
- High risk areas – items that contain asbestos and are damaged increasing the risk of loose fibres
 - o Rear room enclosing toilet – internal and external wall cladding and ceiling lining constructed from asbestos cement sheeting – some sections are damaged and deteriorated – report recommends annual monitoring

Enclosure built around original external brick toilet.
The toilet is on the left side of the photograph
